## Case Study of Seismic Assessment of a Short Irregular Historic Reinforced Concrete Structure: Time-History Vs. Pushover Nonlinear Methods

# Case Study of Seismic Assessment of a Short Irregular Historic Reinforced Concrete Structure: Time-History Vs. Pushover Nonlinear Methods

Department of Civil and Environmental Engineering, University of Cyprus, Nicosia, Cyprus

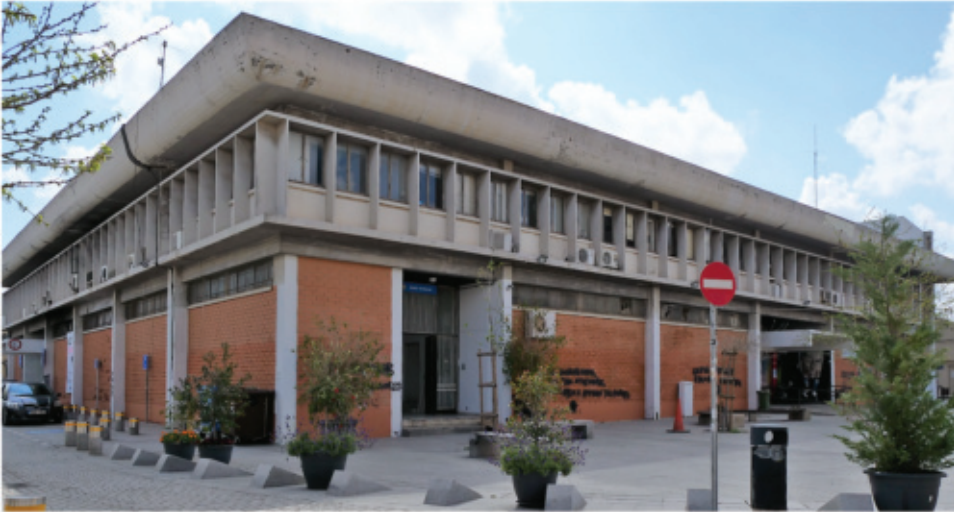
**Figure 1.** Exterior view of the structure (top) and floor plan (bottom) showing the part that was assessed in the present study (in blue).

The Old Municipal Market is located in the central walled city of Nicosia, Cyprus. The building served the public as a market from its inauguration until 2017, when it was abandoned for some years. It is listed as a concrete heritage building in Cyprus and has monumental character and a modernist architectural style. At the moment, retrofit works are undertaken to reuse it as a research center. According to the original plans, it was built between 1964 and 1965 and it had significant socio-economic influences in the walled city. It consists of a basement on a small section of the total floor plan, a ground floor area of 1968 m<sup>2</sup>, and a first floor, which hosted offices of the Municipality of Nicosia. The building is made of reinforced concrete, cast on site, and it is divided by expansion joints measuring  $\geq 3$  cm into 4 statically independent parts. The four individual parts consist of RC slabs, beams, columns, and walls; the latter, according to exploratory excavations, are supported on connecting beams without footings. Most frames on the perimeter of the building have brick infill walls that do not extend to the full column height, thus creating captive columns (Fig. 1). Additionally, there is a great irregularity in the elevation of the structure in terms of stiffness, due to the different height of the floors, a large variation of mass distribution and increased masonry infill percentage on the first floor. Only the part of the structure marked with blue colour in Fig. 1 was selected for analysis. This part has an irregular L-shape, indicating that the center of rotation (CR) is offset from the center of mass (CM). The L-shaped area was chosen as it was the only irregular part of the structure. The other three parts were rectangular in shape, and eccentricities in plan did not exist. Therefore, the pushover analysis is considered more accurate as the primary mode shapes do not include any coupling between the lateral and torsional components. In the other three parts, there is no torsional modal shape.

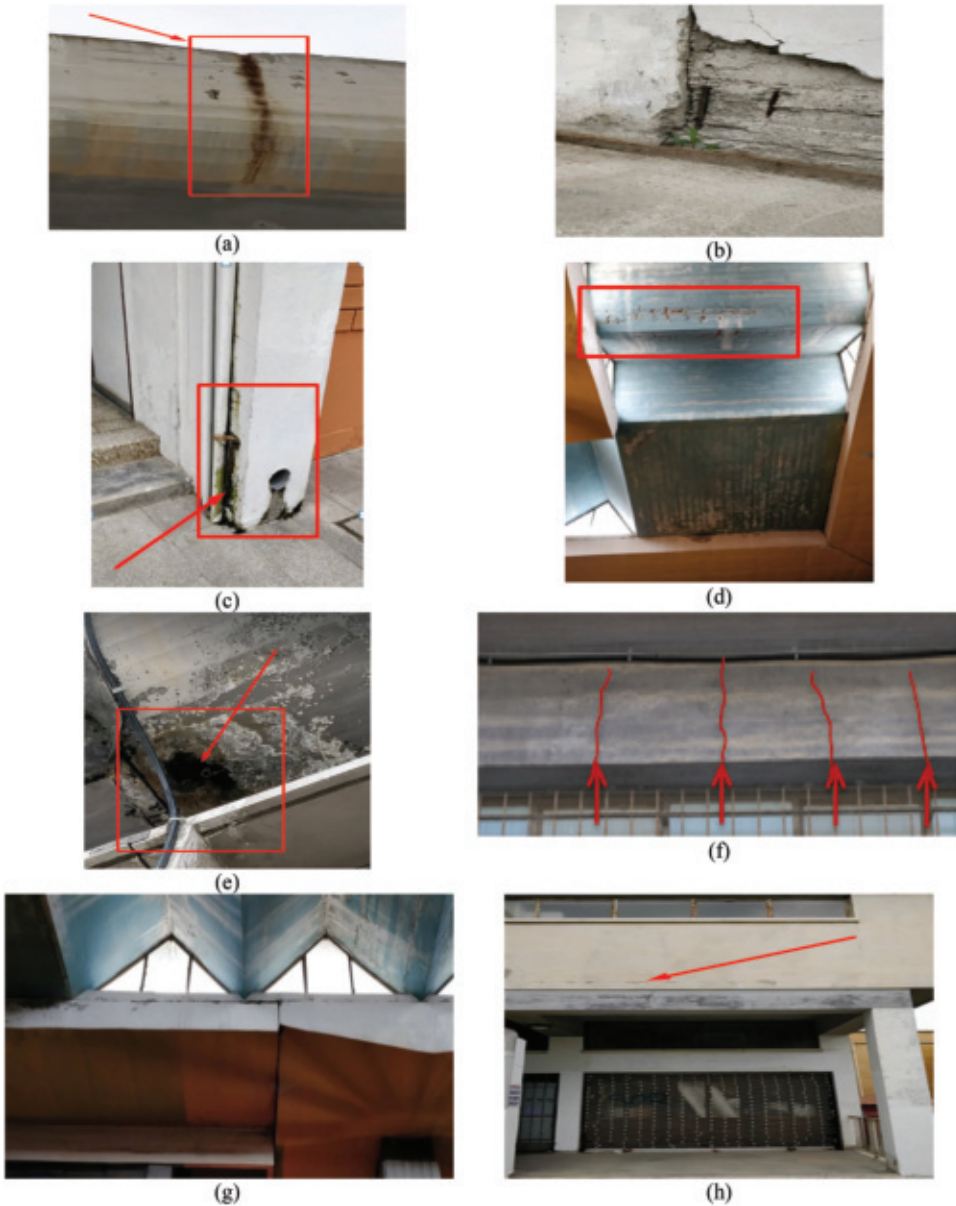
**Figure 2.** Recorded damages in the old municipal market (2019–2020): (a) Rust stains, (b) Cover delamination and rebar corrosion, (c) Water drainage passing through columns with extensive stains and cracking, (d) Poor cover – exposure of reinforcement – extensive erosion, (e) Mold, stains, efflorescence internally under slab, (f) Deflection cracks on beams, (g) Deformations in the cantilever slab, (h) Horizontal cracks at the connections of the infill walls with the structural system.

Typical damages were recorded and are shown in Fig. 2. Cracks are visible in most of the beams. Drainage from the roof passes through some of the external columns of the building, inducing moisture to them and potential corrosion to the reinforcement. The base of the columns with embedded drains, in fact, shows extensive cracking, probably due to the corrosion of the reinforcement. Nevertheless, the overall state of the building is rather good, despite its abandonment and lack of maintenance for many years.

Corrosion is evident in some of the slabs of the first floor, especially at locations where rainwater is ponding on the roof, and in the columns of the ground floor, where the cover to the reinforcement has spalled and the latter is exposed. The slabs at these locations have black stains and show cover delamination. Any deterioration in reinforced concrete is related to moisture, carbonation, and corrosion of the reinforcement. The walls in one of the shops also show some diagonal cracking, which suggests a minor settlement of the foundations. Mosses and blemishes are extensive on the exterior surfaces of reinforced concrete.

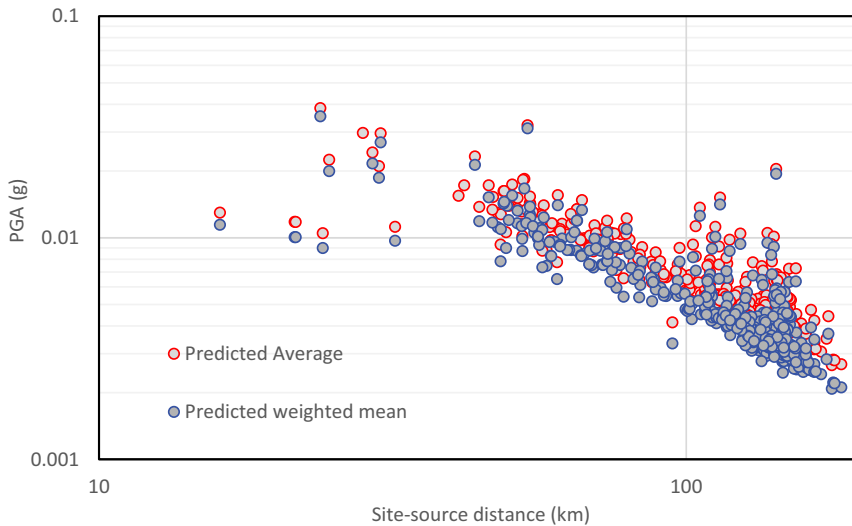
**Figure 3.** Estimated PGA values at the site, for seismic events with  $M_w > 4$  in the period 1963–2019.

felt at the specific site in the period from 1963 (beginning of construction) to 2019 (beginning of retrofitting) was estimated for the seismic events appearing in the catalogue of the Cyprus Geological Survey Department. Earthquake magnitude conversion from  $M_L$  to  $M_s$  and  $M_s$  to  $M_w$  was carried out using the empirical equations of Tselentis (1997) and Mohamed et al. (2012), respectively.

The PGA was estimated based on earthquake magnitude and source-to-site distance as an average (simple and weighted) of the predictions of the attenuation relationships of Theodulidis and Papazachos (1992), Danciu and Akis Tselentis (2007), Tenta, Franceschina, and Marcellini (1992), Joyner and Boore (1981), Boore and Atkinson (2008), with weight factors 0.3, 0.3, 0.1, 0.15, and 0.15, respectively. The averages of the predicted PGA (simple and weighted) are depicted in Fig. 3. The estimated PGA values at the site location, during the life span of the building, have a maximum value of roughly 0.035 g, corresponding to lateral loads equal to 3.5% of the weight of the structure. The force applied on the structure is well below the Base Shear for yielding, and thus none of the cracking observed on the structural members can be attributed to earthquake shaking.

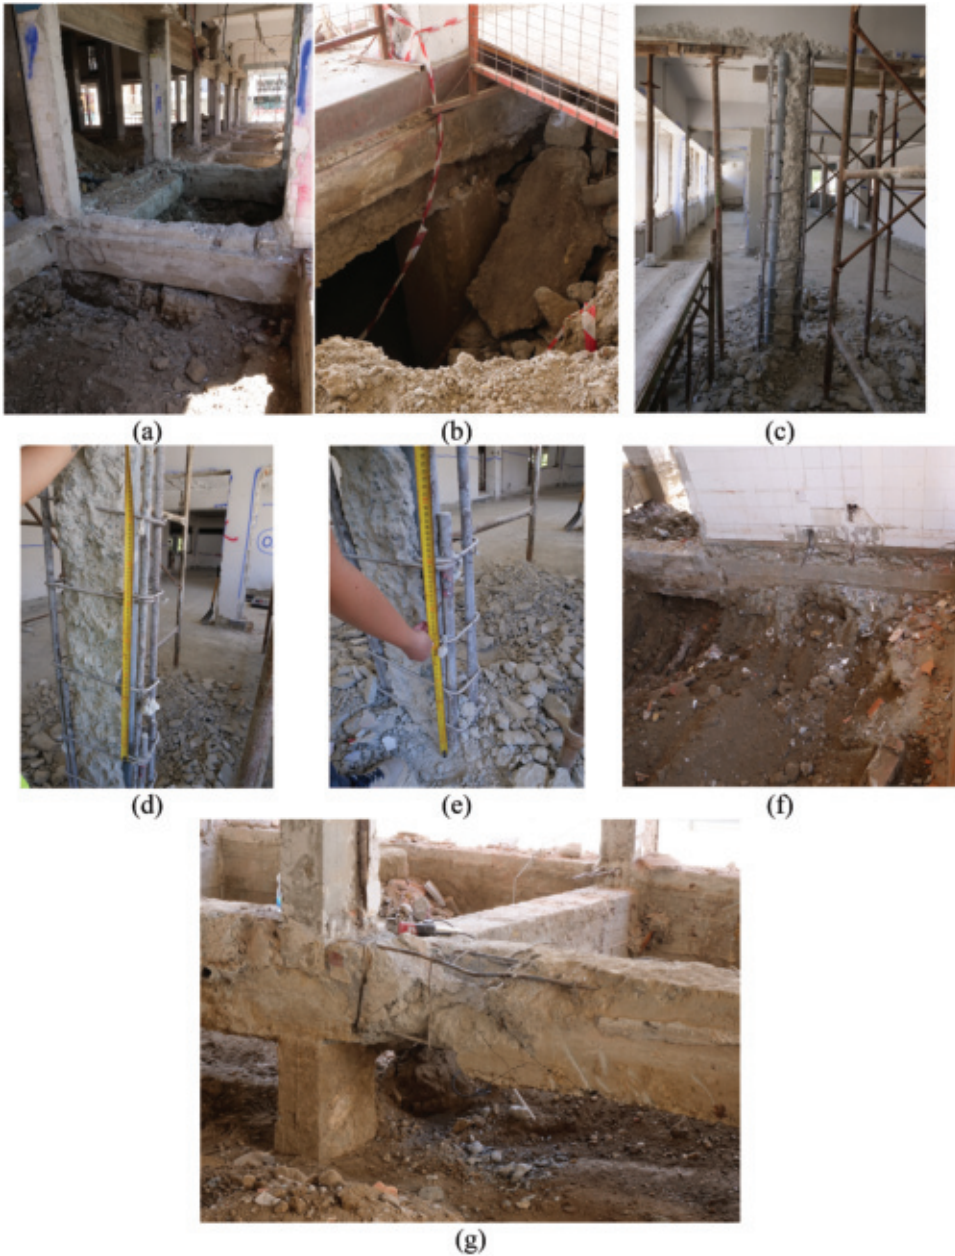
**Figure 4.** Exploratory excavations and concrete cover removal during retrofit works: (a) lack of foundation slab, (b) holes and ancient ruins under the foundation system, (c) drainage pipes within columns, (d) insufficient stirrup spacing, (e) insufficient lap splice length, (f) lack of foundation of the R/C wall, (g) insufficient flexural and shear reinforcement on foundation beams.

The reinforcement was in close agreement with the original detailing drawings. Exploratory excavations showed that the columns continued up to 2 m underground, in order for the foundation (consisting of isolated footings) to reach a firm ground. Some voids were found below the ground floor slabs. The columns at the foundation level were connected with beams with very sparse reinforcement. Many of the columns had drainage pipes embedded in them (something that is now forbidden by the building codes). Stirrups in beams are sparse and not suitable for ductile structures and/or the formation of plastic hinges at the edges of members. The lap splicing of the longitudinal reinforcement was also found to be less than what is required in current seismic codes. Additionally, the reinforced concrete walls shown in the original drawings were connected only on beams at the foundation level (Fig. 4), leading to the conclusion that they cannot attain flexure due to the lack of foundation system.

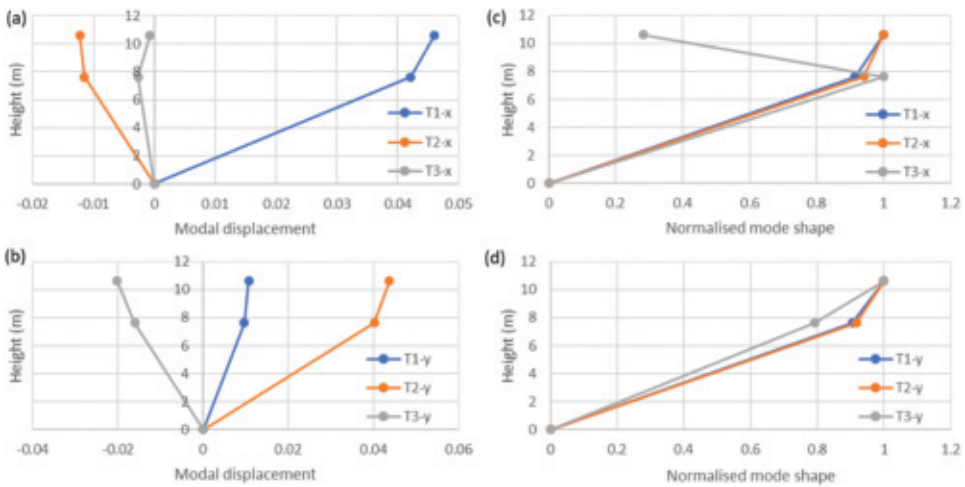
**Figure 8.** Displacements from modal analysis at the CM (a) X-direction, (b) Y-direction and mode shapes heightwise (c) X-direction, (d) Y-direction.

Additionally, when the mode shapes are plotted height-wise (Fig. 8), it is clear that the structure behaves as a pilotis, with a soft ground floor storey, indicating that during seismic loading, most of the displacement that will be induced in the structure due to the motion will be undertaken by the ground floor columns, leading to increased levels of ductility demand. This is also evident by the floor characteristics, such as their height, mass, and stiffness (Table 6).

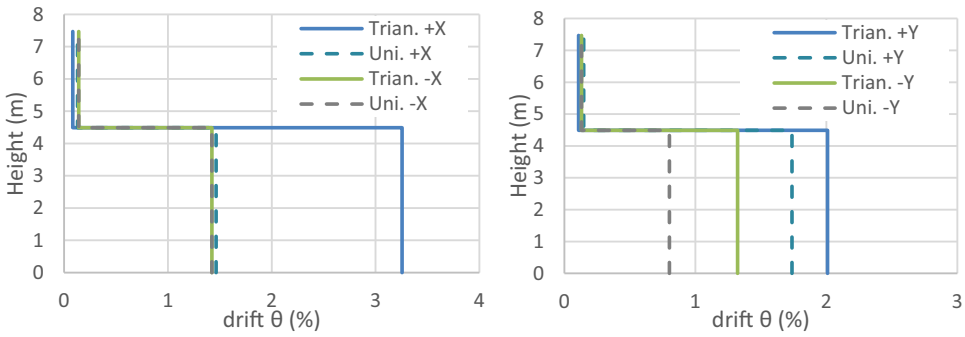
**Figure 10.** Drift demands from pushover analysis in X-direction (left) and Y-direction (right).

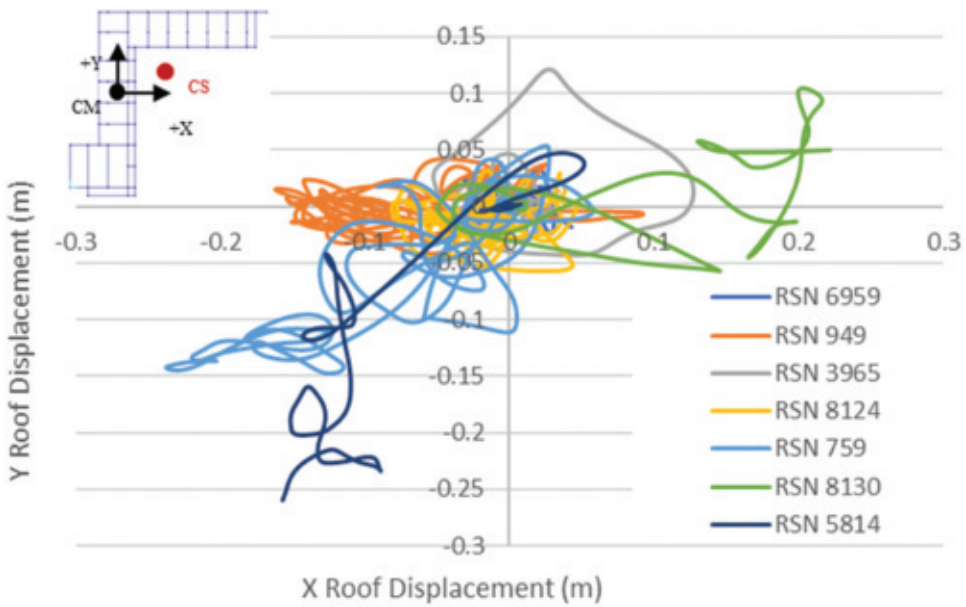
Figure 14. Spatial displacements from all time-history analyses.

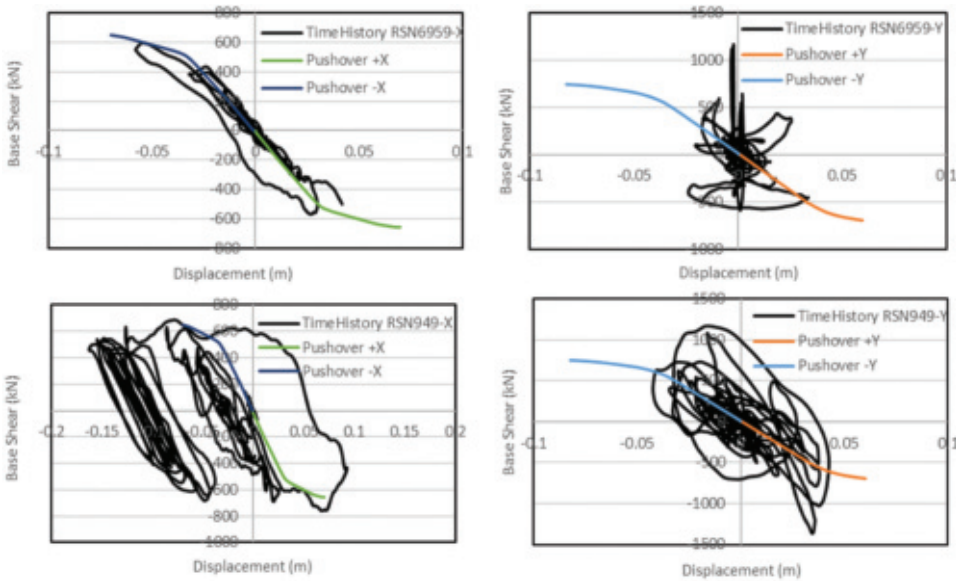
Figure 15. Base shear vs displacement curves for seismic events RSN 6959 and RSN 949 compared to pushover analysis curves.

The hysteretic curves (base shear vs. displacement of the first floor CM) resulting from two sets of accelerograms are compared to the pushover curves in Fig. 15, for the two horizontal directions of motion (X and Y). While some of the time-history results are within the limits of the pushover curve, in others, either the total displacement capacity or the base shear capacity exceeds what is obtained from the pushover analysis. This is attributed to the fact that, in the pushover analysis, the applied forces on the floors have a constant ratio throughout, while in the dynamic analysis, redistribution allows the structure to sustain greater total displacements and base shear.
